Manhole Inspection Summary

Manhole # S15GG1029MH

Location Address: **ROLAND VIEW AVE ALLEY**

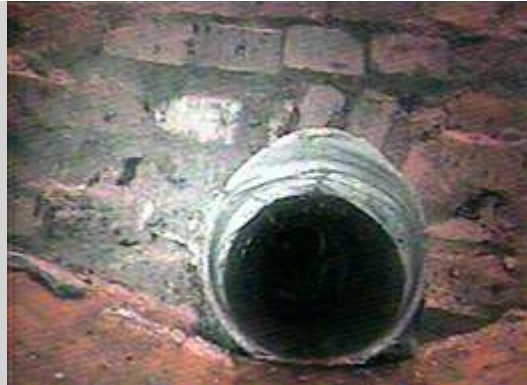
12 O'Clock Outflow

8 in. Circular Gravity Sewer
Pipe Out @ 12 O'Clock

Deposits: ☐ None ☐ Mud ☐ Sludge ☒ **Debris** ☐ Grease

Silt Depth: **2** (in.) Deposits Extent: **Light**

Infiltration: **None** Pipe Seal Cond: **Cracked**
